RALSTON CREEK AT CROKE CANAL ARVADA, COLORADO

CLIENT: Mile High Flood District & City of Arvada

- Completed under MHFD's Capital Improvements Program, in partnership with the City of Arvada, to address Ralston Creek's health and flood resilience after the 2013 flood
- Assessment of existing conditions and a hydrology and hydraulics (H&H) analysis
- Design focused on containing the 25-year storm within the flood corridor
- Sustainable channel stabilization, including:
 - ▶ Riffle-pool sequence
 - ▶ Sculpted concrete drop structure
 - ▶ New community recreational area
- Additional improvements:
 - ▶ Pedestrian bridge replacement
 - ▶ Upgrades to the Ralston Creek Trail
 - ▶ Tree removal and new vegetation plan
- Community benefits
 - ▶ Flood protection
 - ▶ Recreation
 - ▶ Environmental stewardship

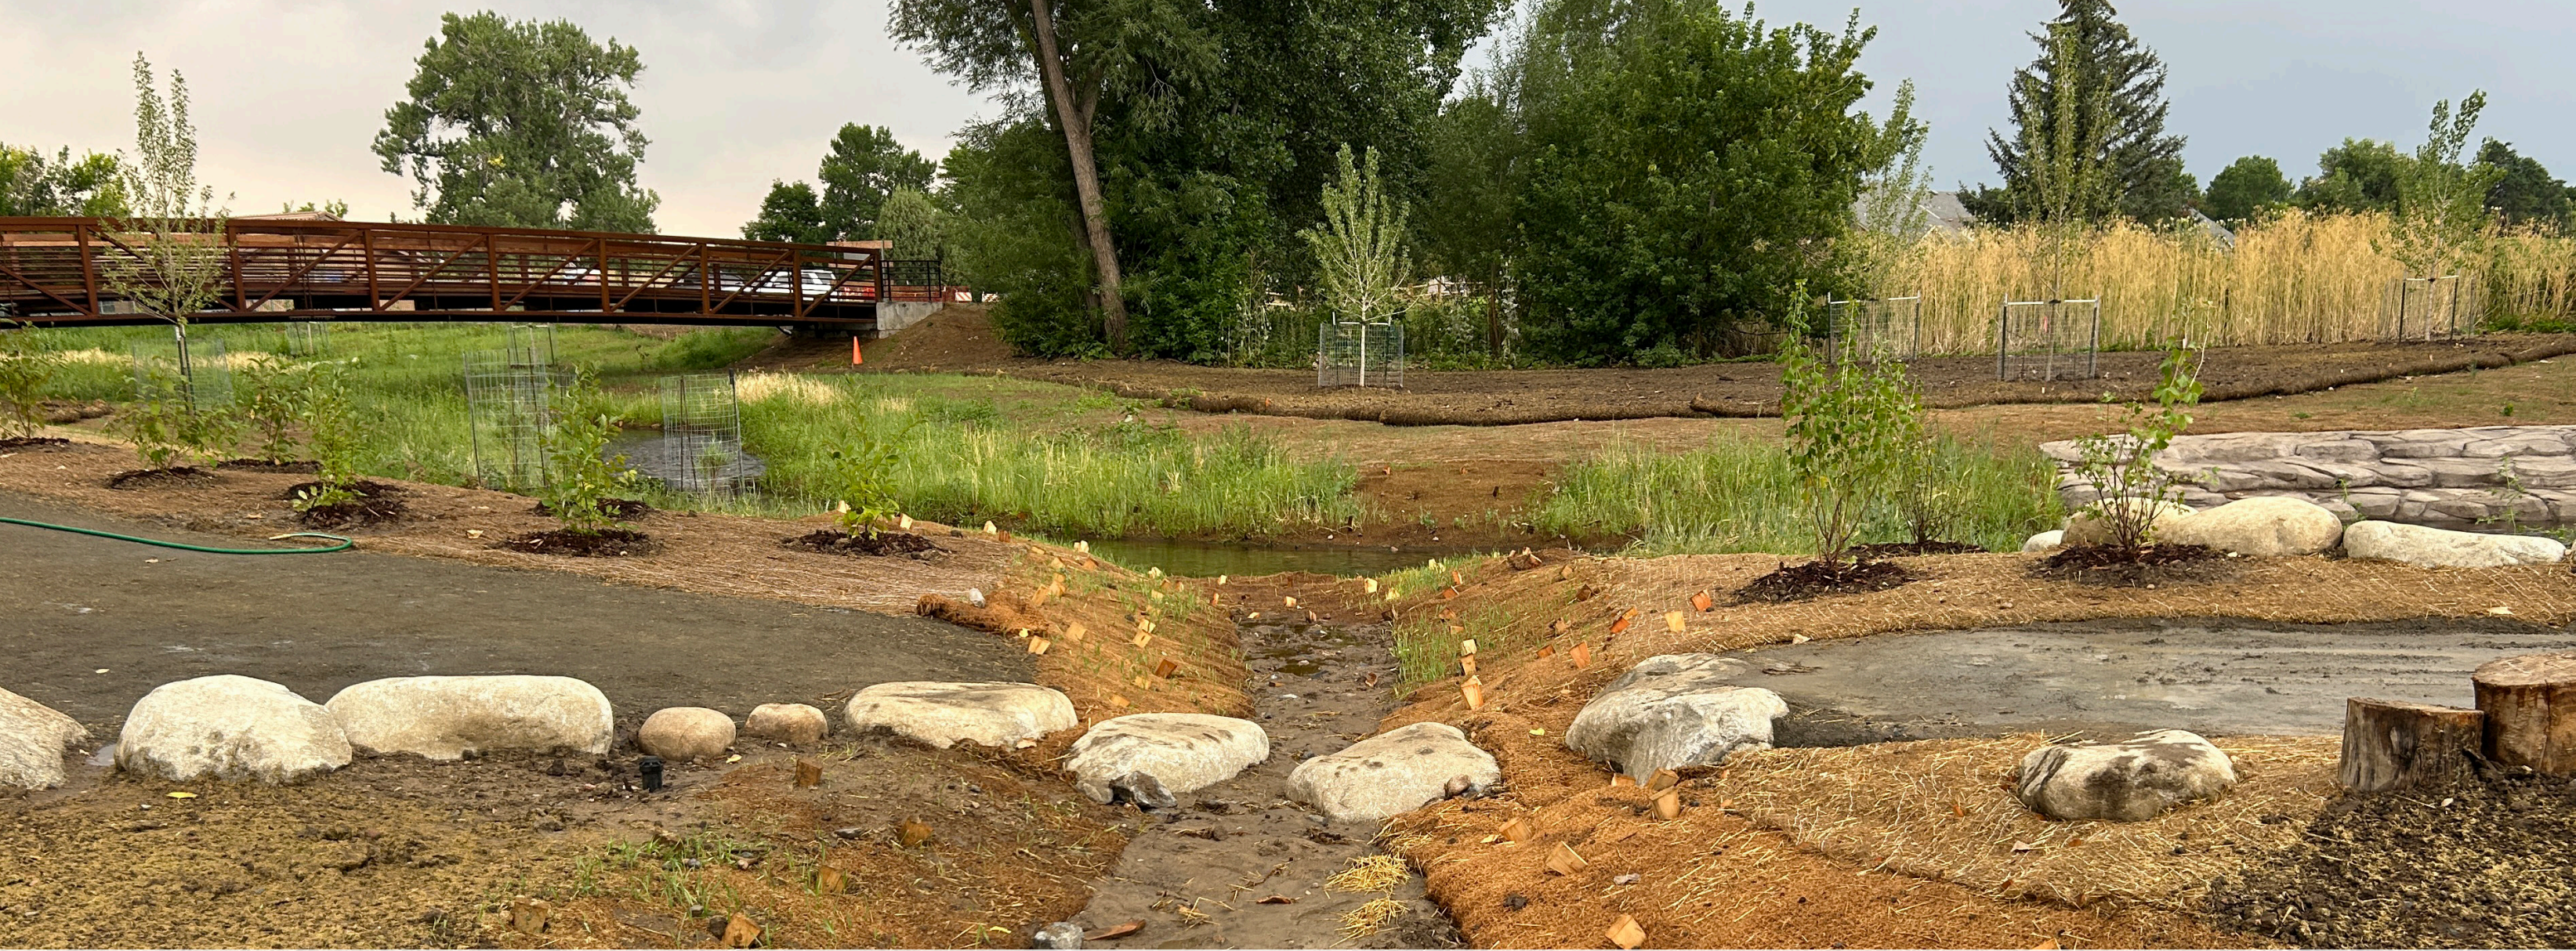
Boulders and logs installed to create natural play areas and improve stream access.

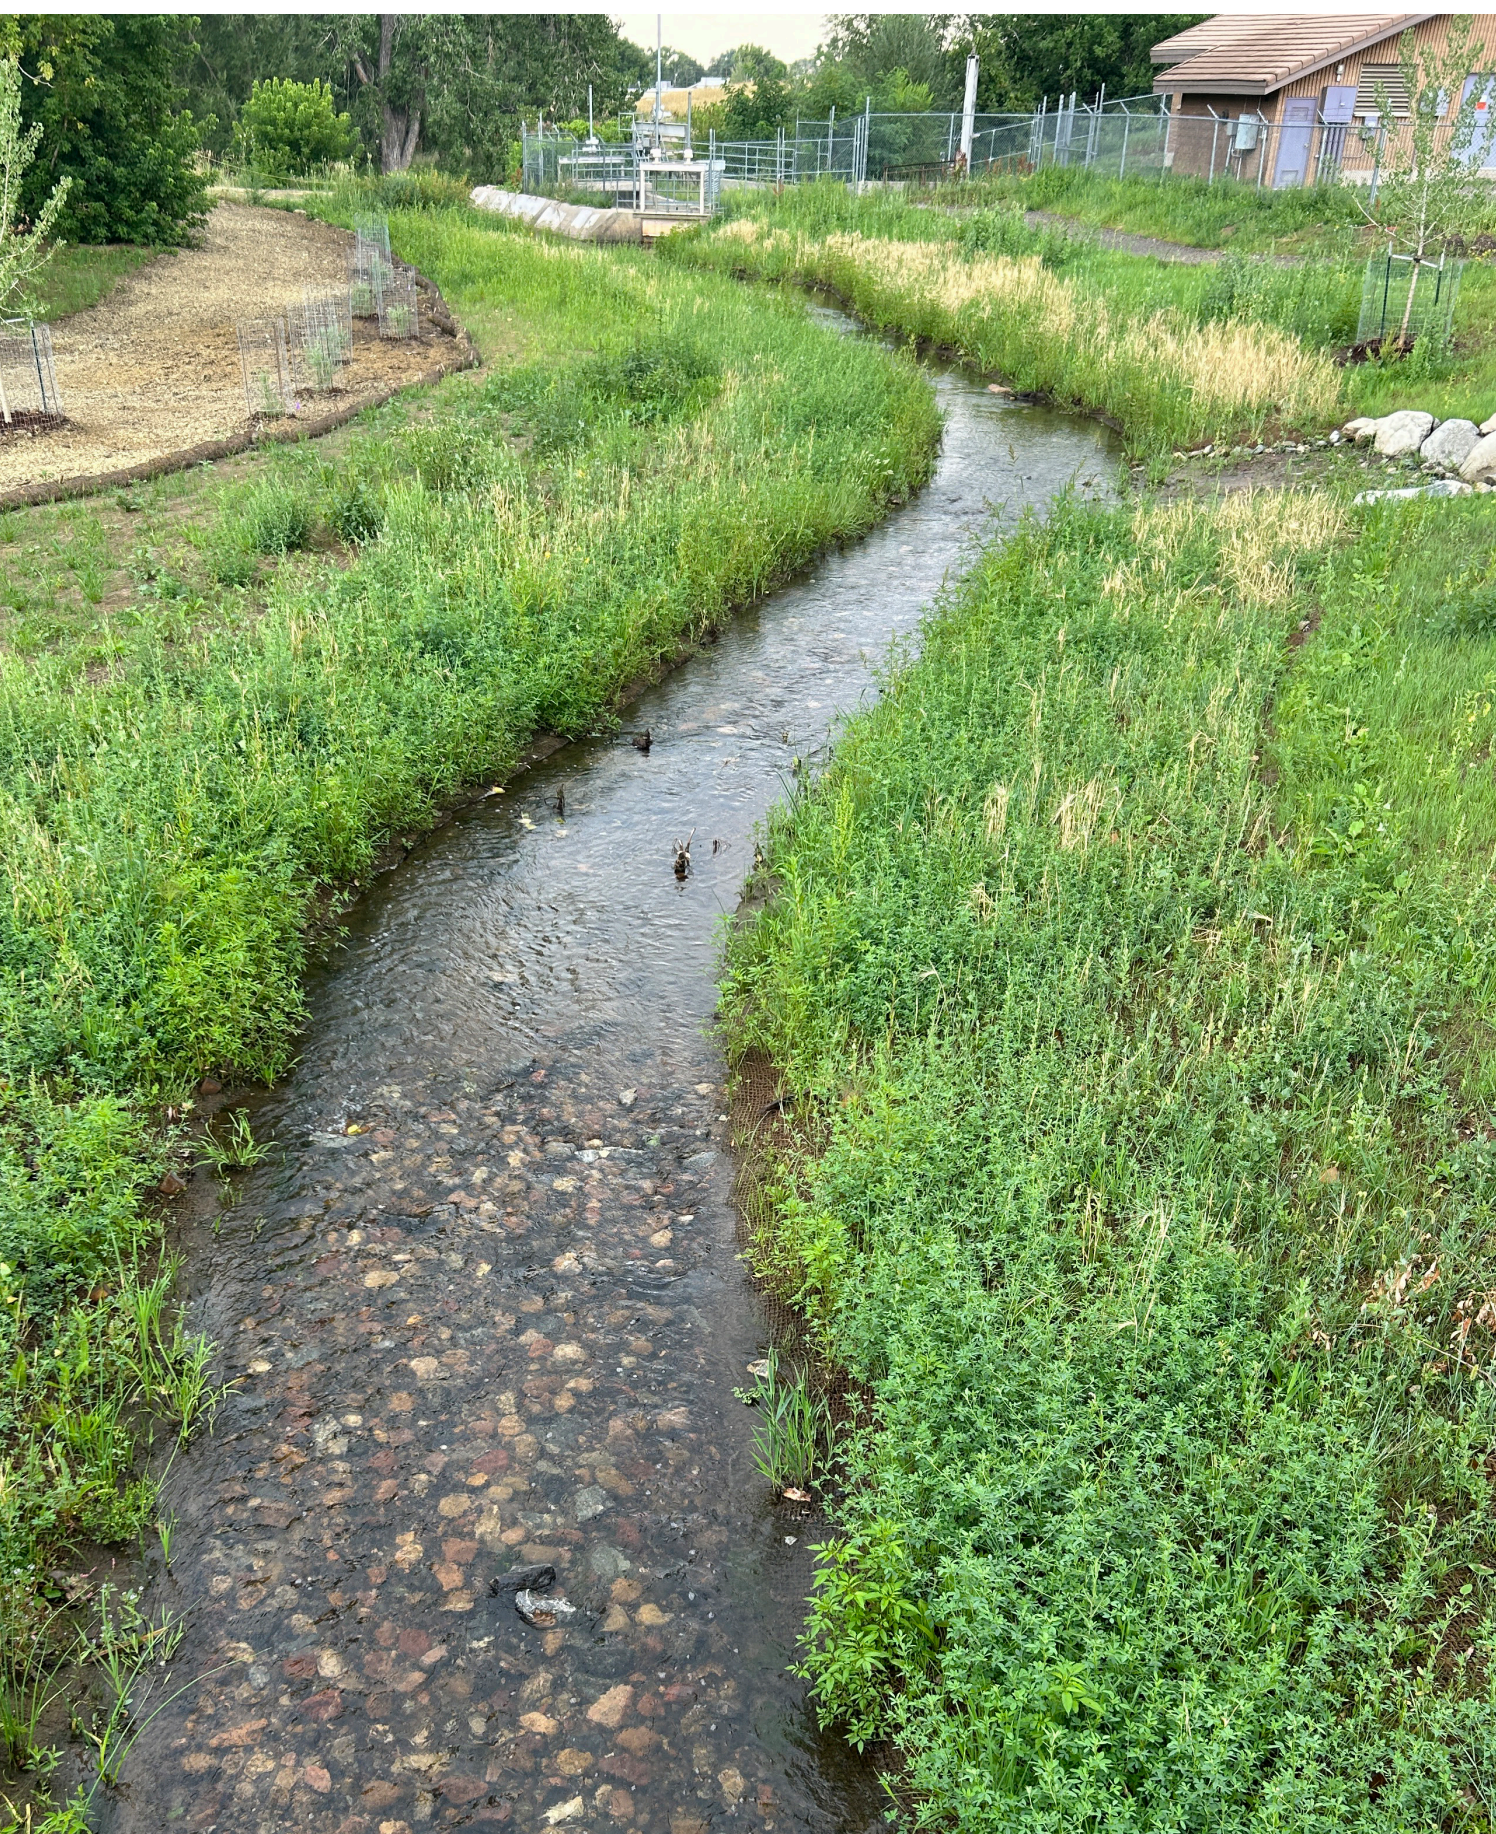
Stream improvements increased the flood capacity and allow for easier access to the creek.

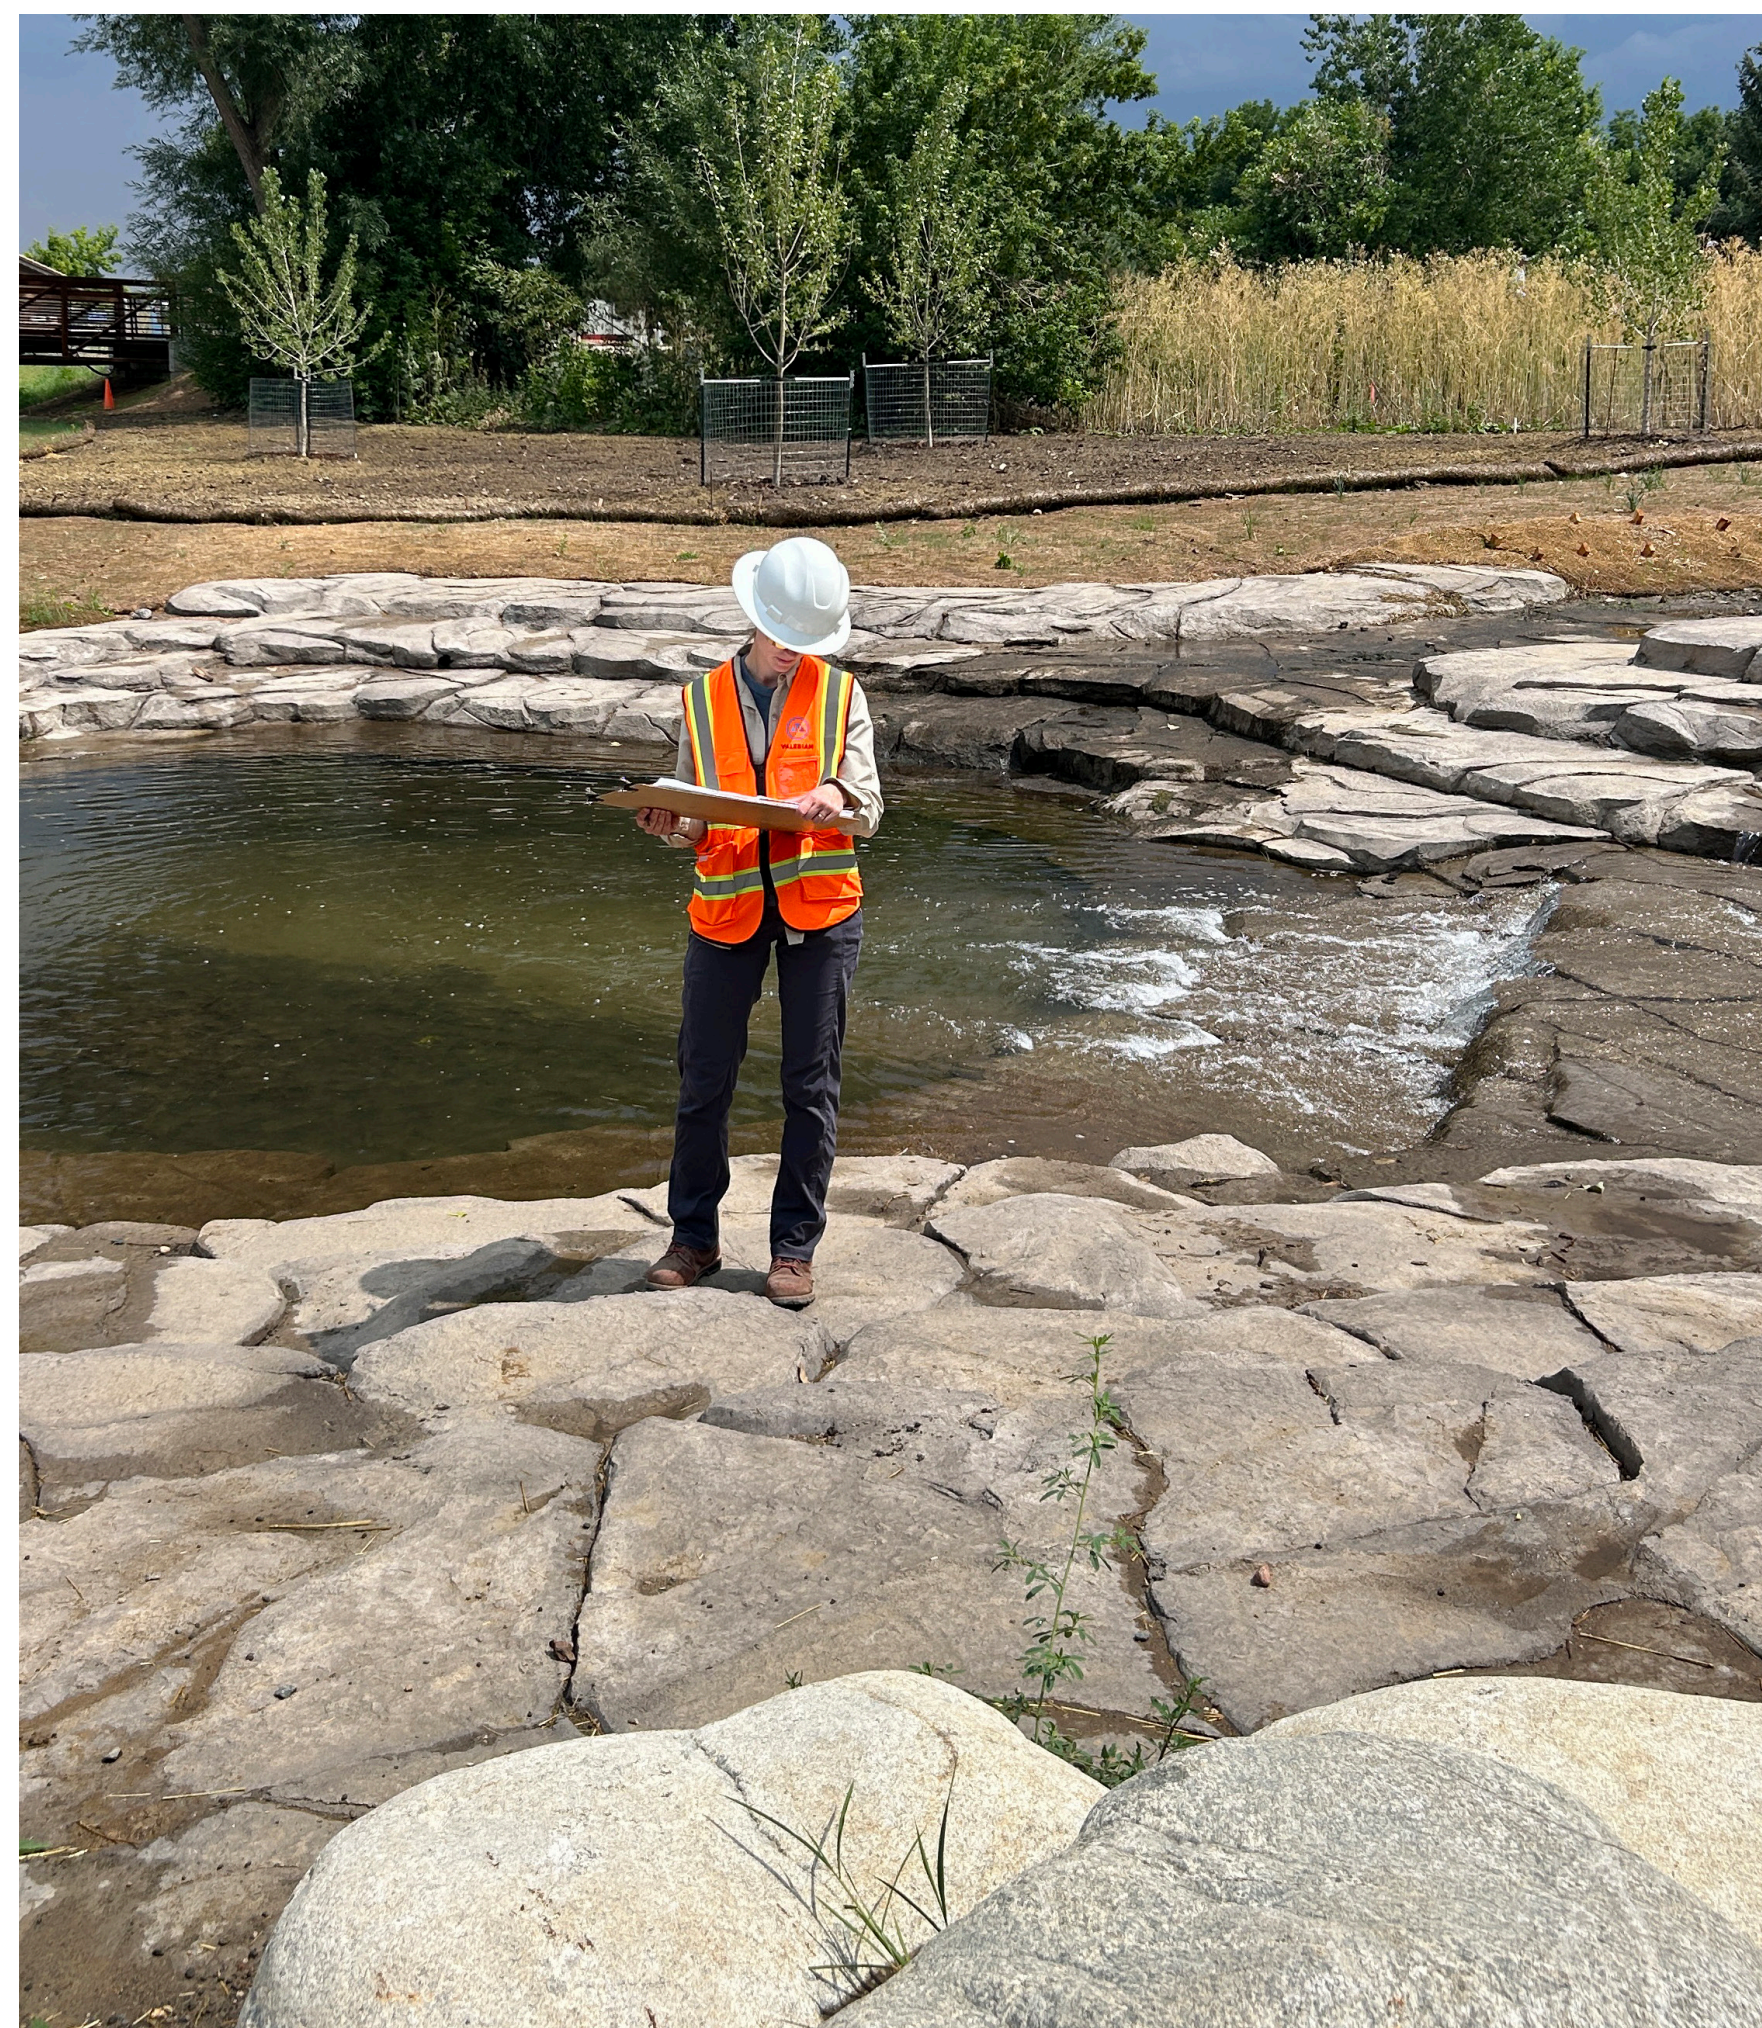
Stream structure mimics natural bedrock.

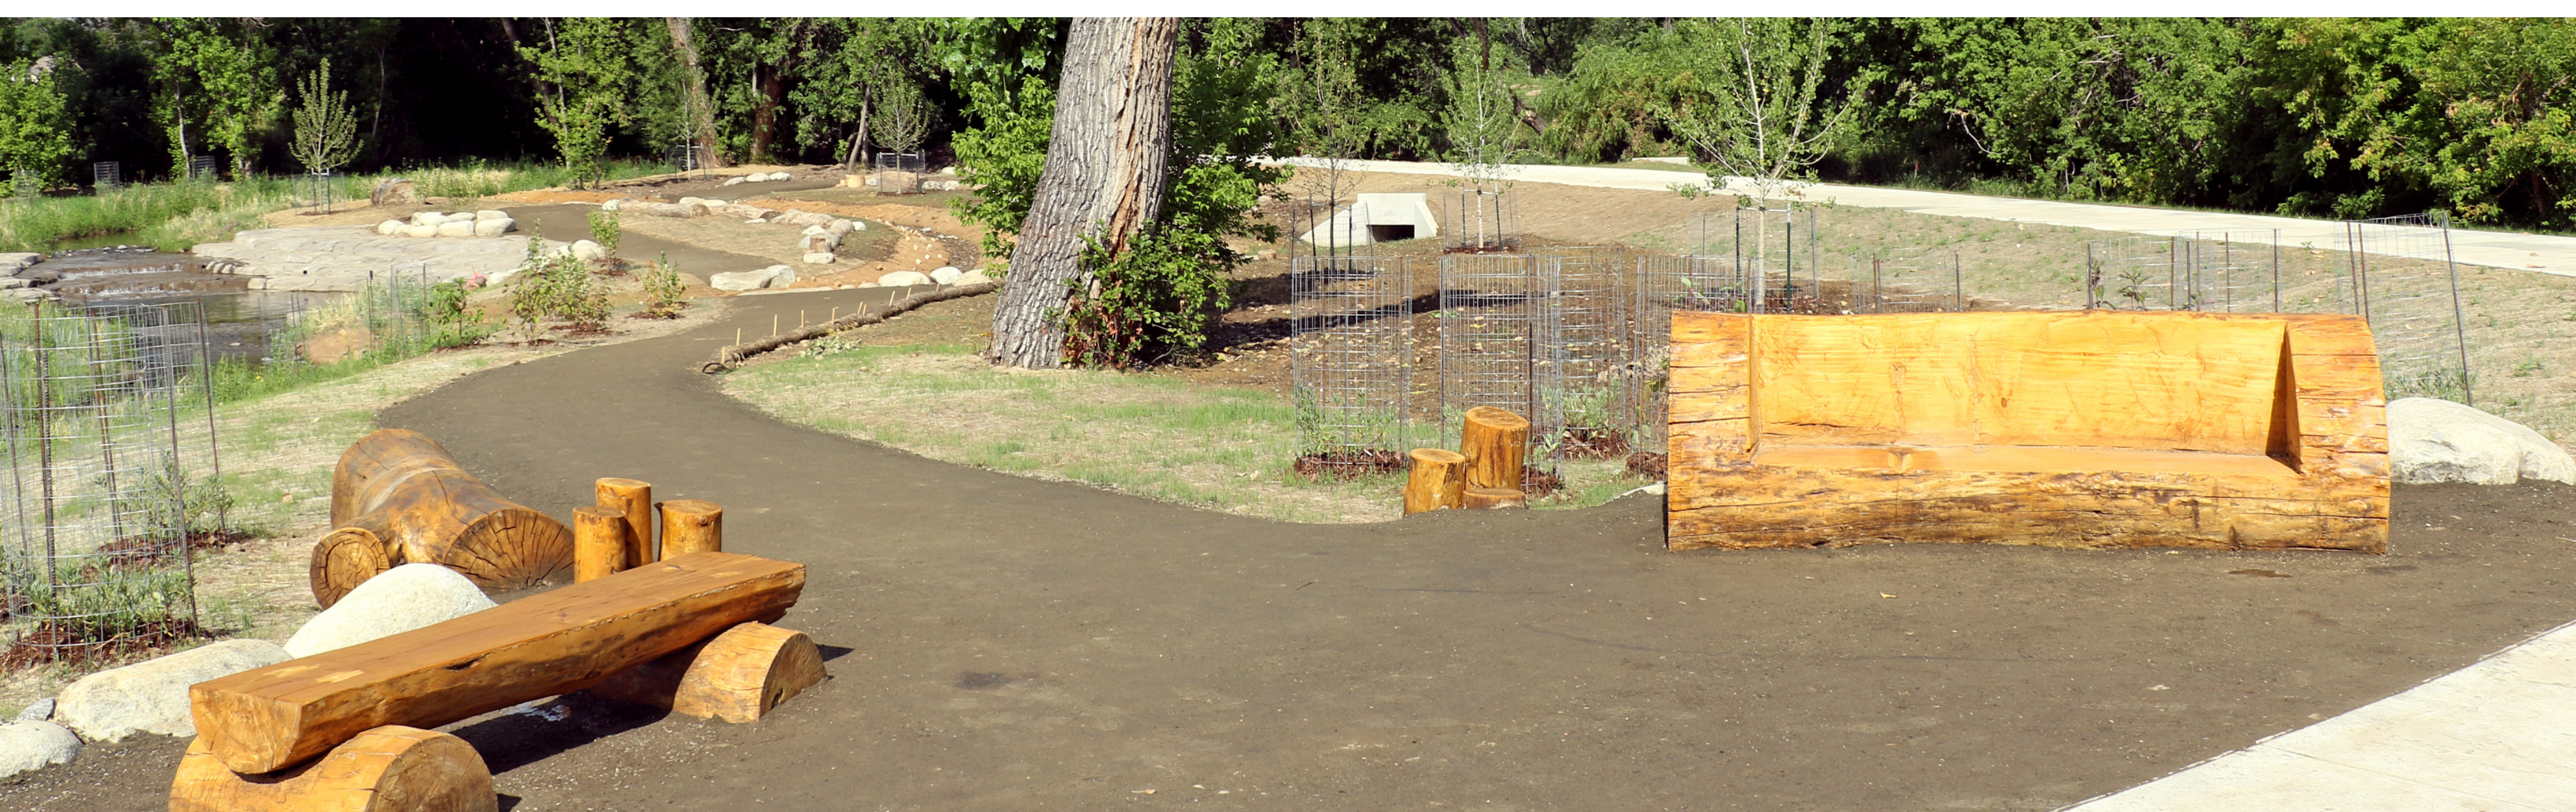
Recycled trees were placed throughout the recreation area for seating and play structures.

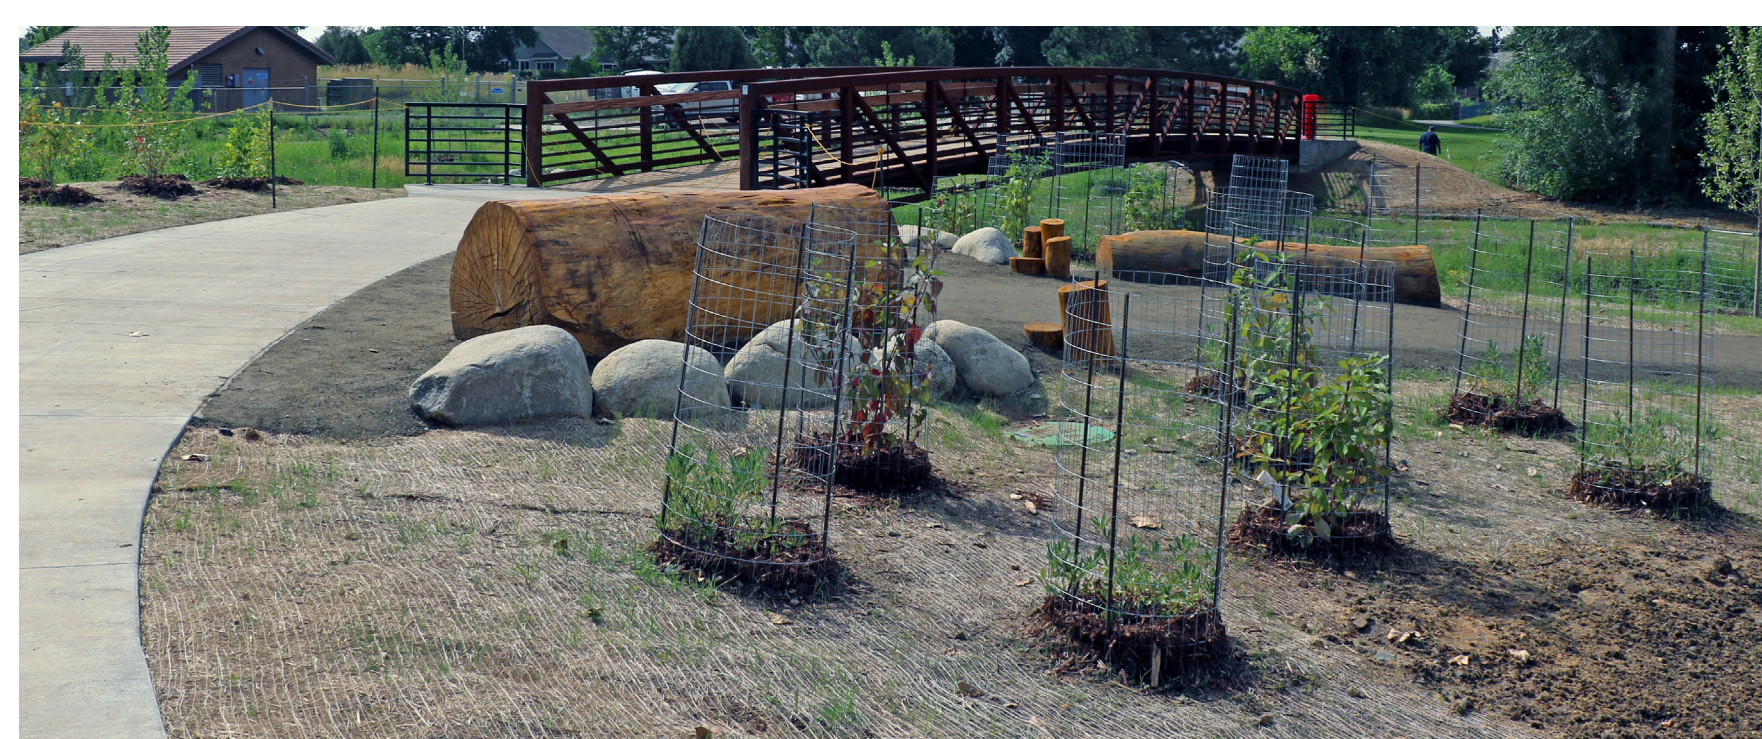
New vegetation plantings.

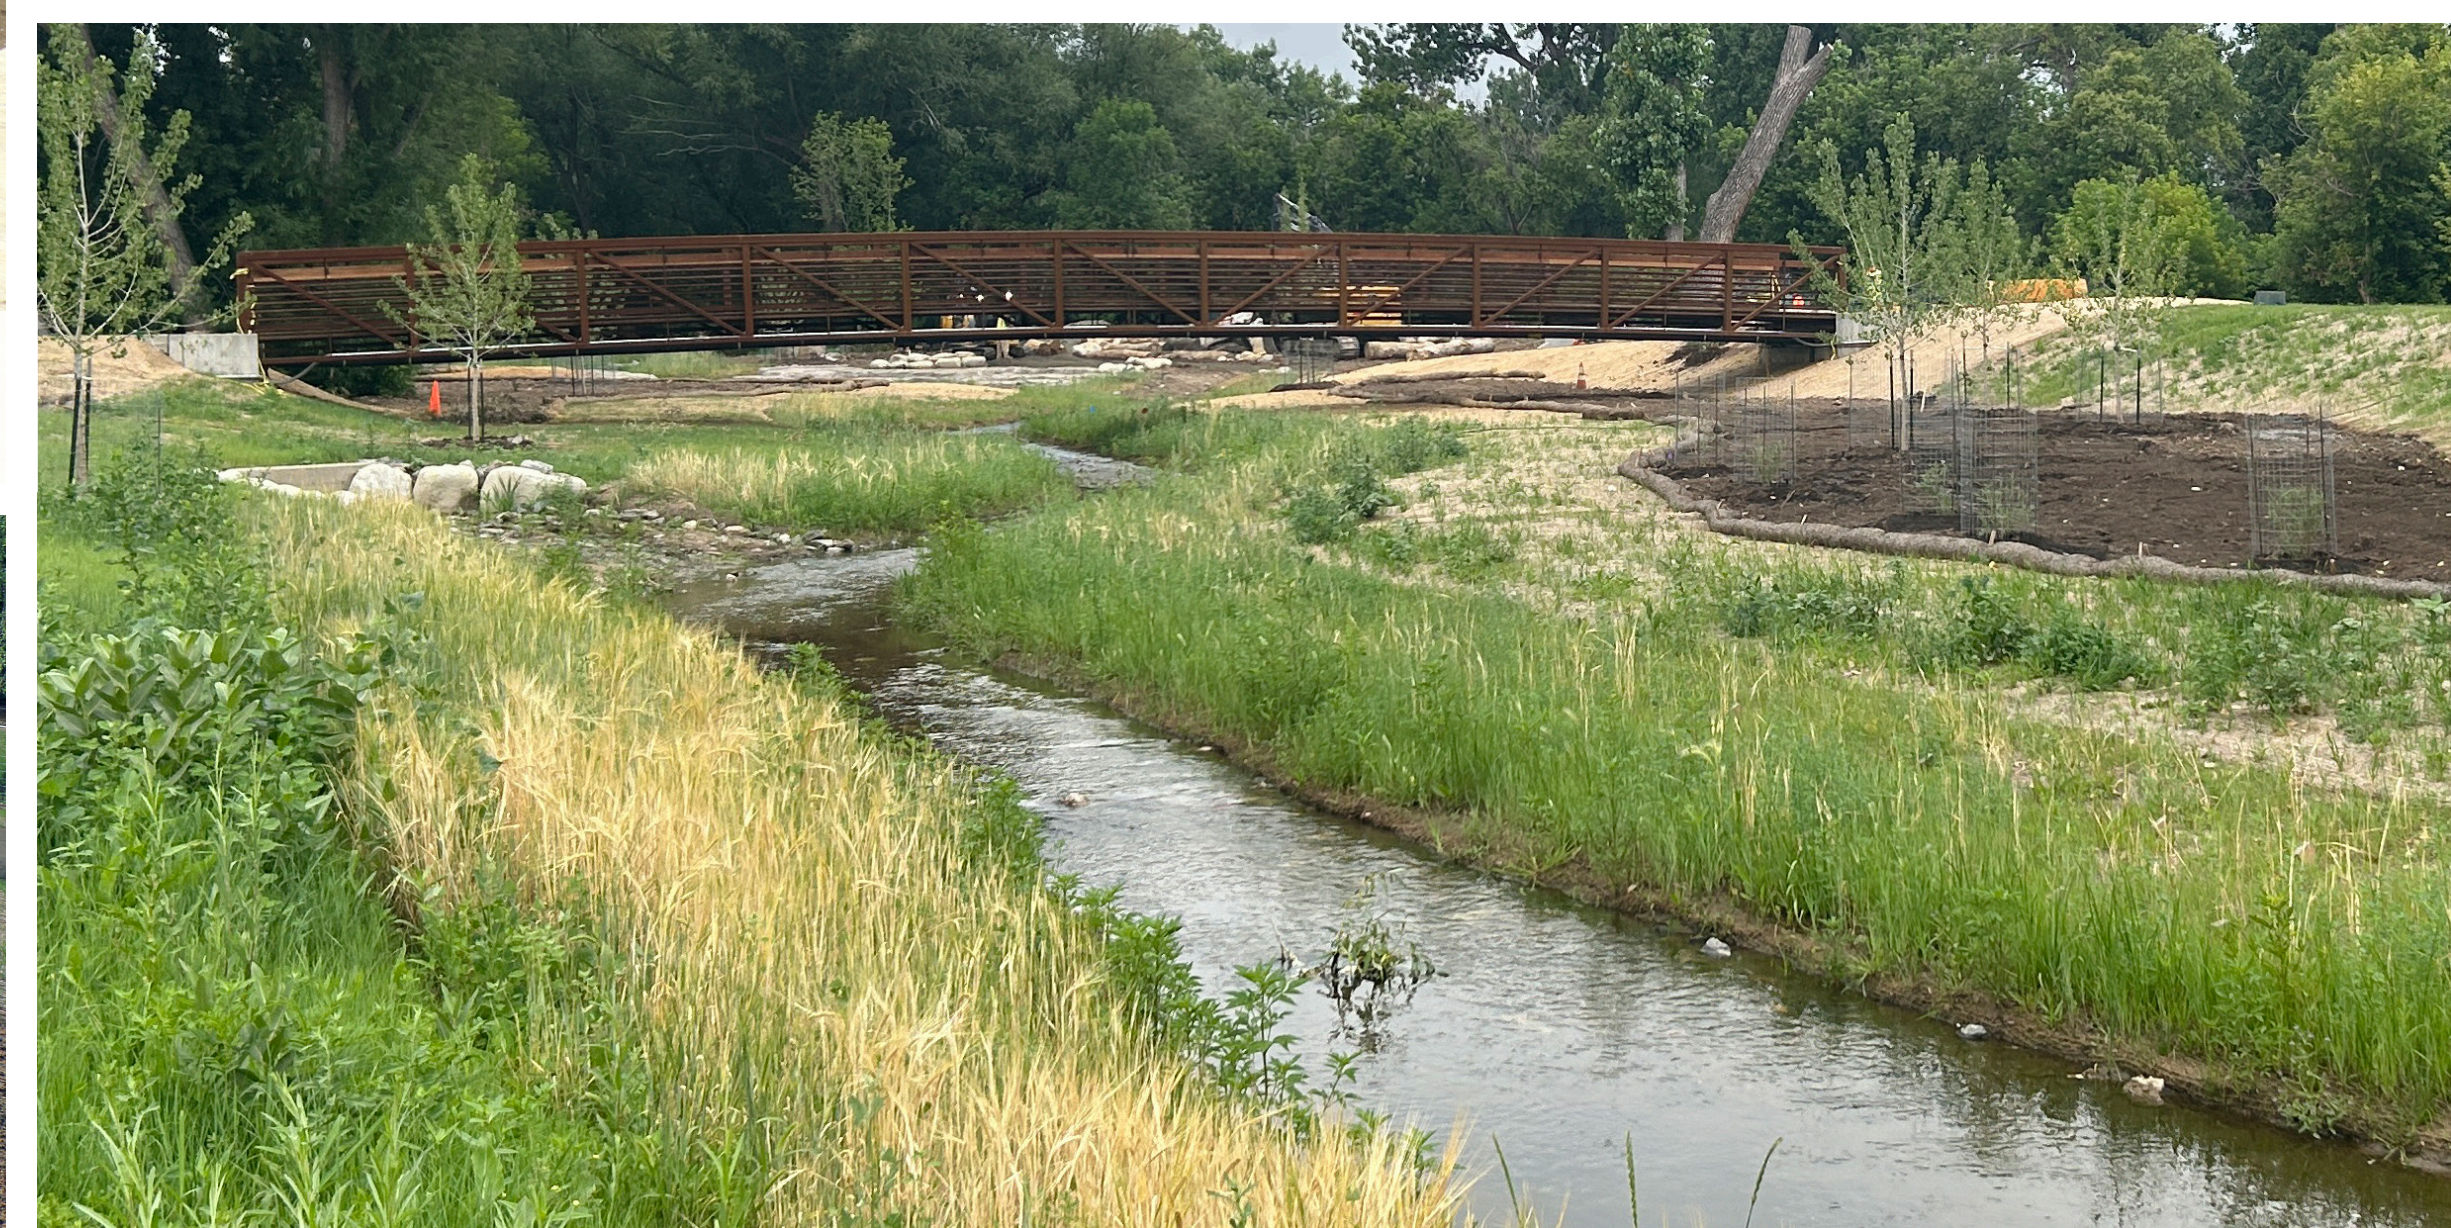
Project stabilized the channel and installed a new pedestrian bridge.
